DOT/FAA/AR-01/27

Engine Debris Fuselage Penetration Testing, Phase I

August 2001

Final Report

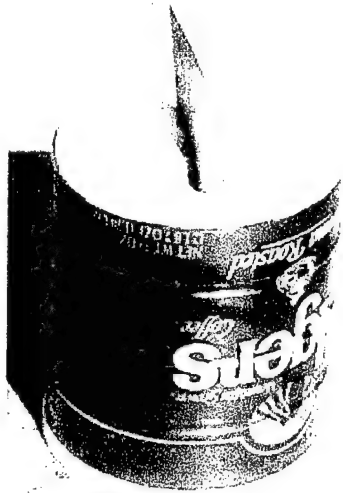
FIGURE 8. FINAL SABOT DESIGN WITH LOADED FRAGMENT

An example of the sabots can be seen in figure 8. A coffee can, Teflon, and Styrofoam to build the sabots were used. The Teflon was used as a backing plate to prevent the gas blast from destroying the foam. The coffee can had to be made slightly smaller in diameter to fit the gun, but worked wonderfully. The previous tests' sabot designs were very heavy and outweighed the projectile by many times. Stopping those sabots at the energies of this test was going to be expensive. Three sabot stopper plates of 3 in. Society of Automotive Engineers (SAE) 4140 steel were broken during the pretest experiments.
